Reasoning and Post-Disaster Damage Assessment for the Petrochemical Pipeline Explosion using UAV Techniques

Kuan-Tsung Chang^{1*}, Min-Cheng Teng², Gwo-Chyang Tsuei³, Cheng-Fang Lo⁴, Jin-King Liu⁵

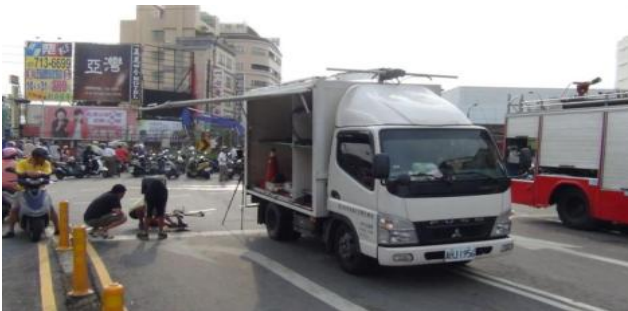
Figure 1. The preparation for aerial survey

After the explosion event of Kaohsiung petro-chemical pipeline, the National Science and Technology Center for Disaster Reduction (NCDR) entrusted the National Land Surveying and Mapping Center(NLSC), Ministry of Interior to collect post-disaster information of 6km² explosion area during 24 hours. An aerial survey was performed by the Geosat Aerospace & Technology Inc. on August 1, 2014. The preparation for aerial survey is shown as Figure 1. A four-axes drone with a Canon EOS 5D Mark II camera had been used in this flight mission. A photograph taken at beside of road section in the explosion area is shown as Figure 2. And a quick overlook came from the Drone is also shown as Figure 3. A total of 502 images were taken at a flight altitude of 200 meters. The dimension of each image is 4384x3288 pixels, the frame size of sensor is 36x24 mm, and average ground sample distance (GSD) of images is 4.8 cm.

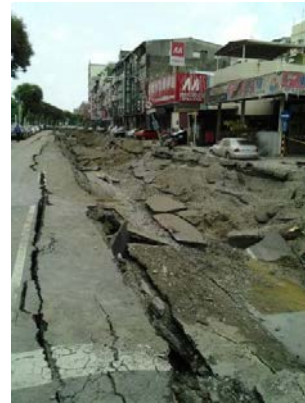
Figure 2. A road section in the explosion area

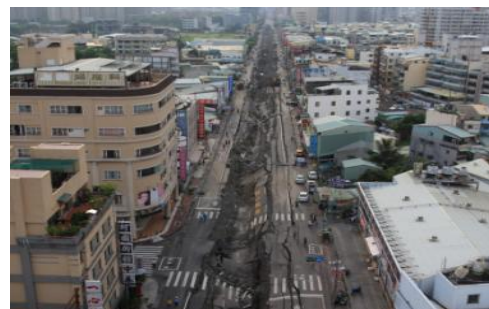
Figure 3. A quick overlook came from the Drone

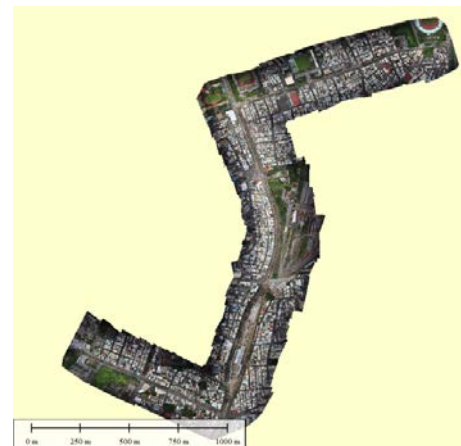
Figure 4. An orthophoto result for post-disaster assessment

After imaging, all taken images were imported into the Pix4Dmapper 1.2.62 version software to perform photogrammetric processing of digital images and generates 3D spatial data. The computation results indicate that number of 2D keypoint observations for Bundle Block Adjustment is 7688561, number of 3D observations is 2160240, and mean projection error is 0.117m. Finally, an orthophoto for post-disaster assessment is shown in Figure 4. The corresponding sparse Digital Surface Model (DSM) is shown as Figure 5.

Although there are no ground control points used in the processing, but the fast mapping results still provide overall and real-time important information for post-disaster rescue and restoration work.

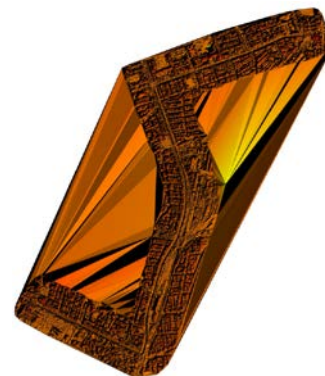
Figure 5. The corresponding DSM before densification
